Manhole Inspection Summary

Manhole # S11Y__014MH

Insp Date: **12/11/08 11:07 AM**

Location Address: **1202 S. Caton**

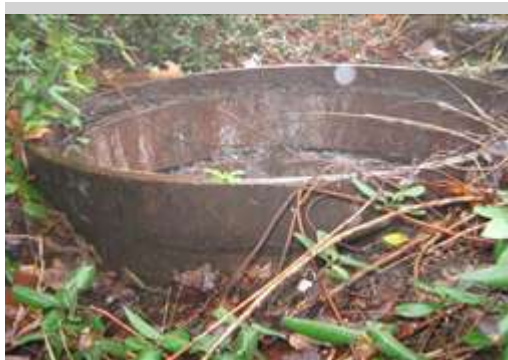
Misc

above grade one foot

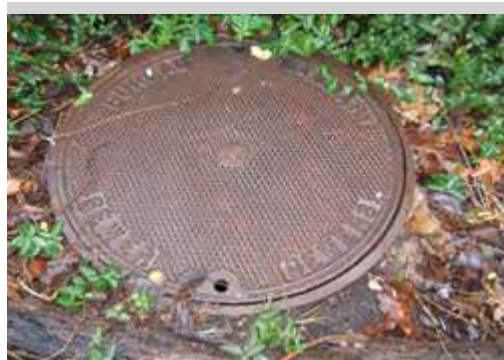
Misc

Condition: **Sound**

cover

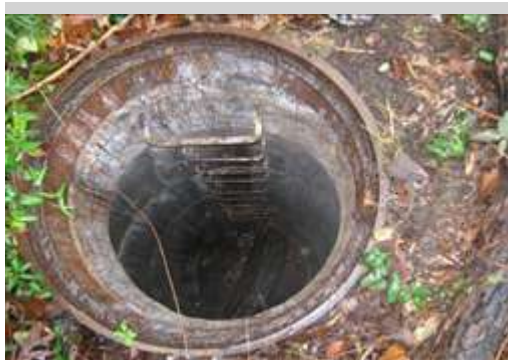
Misc

frame

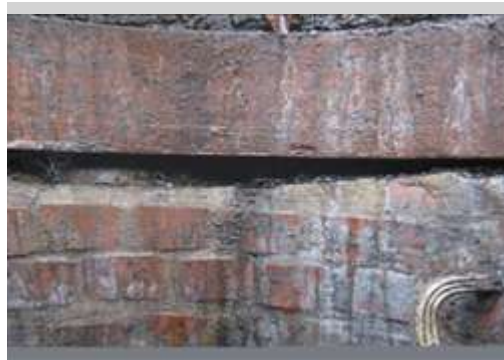
Defect 3

Infiltration: ☐ None ☒ **Joint** ☐ Cracks ☐ Mortar ☐ Roots ☐ Wall

chimney infiltration at frame joint, 2" gap

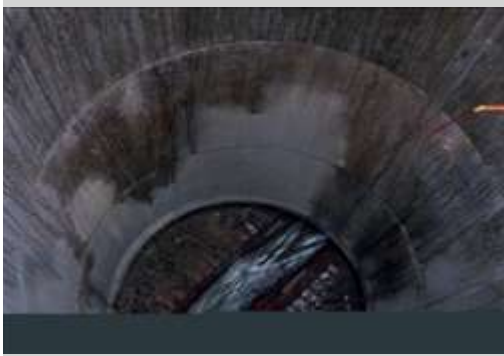
Defect 2

Infiltration: ☐ None ☐ Joint ☐ Cracks ☐ Mortar ☐ Roots ☒ **Wall**

infiltration corbel and barrel walls

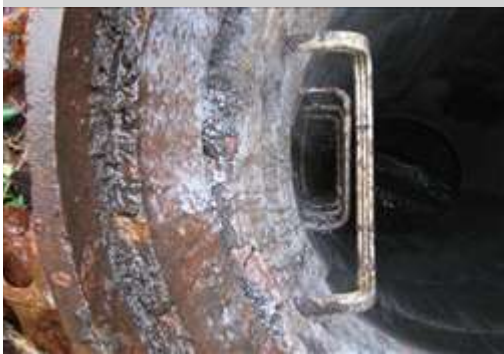
Defect 4

Frame Offset: **2** (in.)

☒ **Leaks**

frame offset 2 inches, frame infiltration at cover

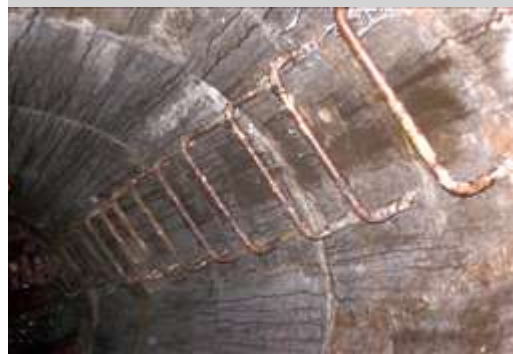
Defect 1

Steps Count: **17** Missing: **0** ☒ **Corroded**

steps corroded

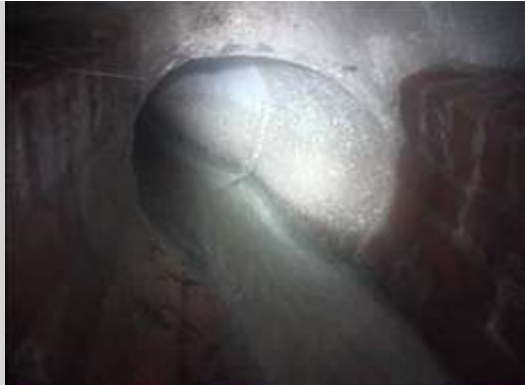
12 O'Clock Outflow

15 in. Circular Gravity Sewer
Pipe Out @ 12 O'Clock

Pipe Height: **16.8** (in.) Rod and Bar (Angled)
Pipe Material: **Clay** ☐ Pipe Lined
Invert Depth: **21.10** (ft.) Flow Characteristics: **Fast**
Deposits: ☒ None ☐ Mud ☐ Sludge ☐ Debris ☐ Grease
Silt Depth: **0** (in.) Deposits Extent:
Infiltration: **None** Pipe Seal Cond: **Sound**

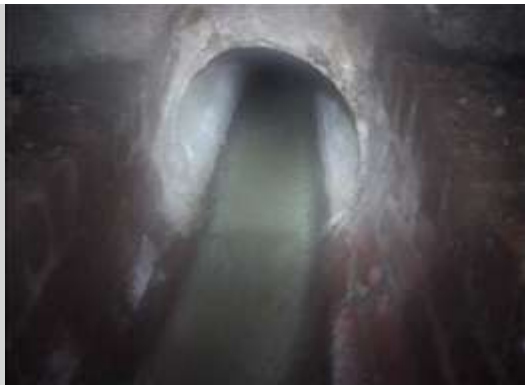
6 O'Clock Inflow

15 in. Circular Gravity Sewer
Pipe In @ 6 O'Clock

Pipe Height: **16.8** (in.) Rod and Bar (Angled)
Pipe Material: **Clay** ☐ Pipe Lined
Invert Depth: **20.90** (ft.) Flow Characteristics: **Fast**
Deposits: ☒ None ☐ Mud ☐ Sludge ☐ Debris ☐ Grease
Silt Depth: **0** (in.) Deposits Extent:
Infiltration: **None** Pipe Seal Cond: **Sound**
